**Flood Control Project Maintenance  
Levee Inspections**  
**LMA District Cover Sheet**  
**Spring 2012 Levee Inspection Results**

**Reclamation District No. 1600 Mull**

**Flood Control Project Maintenance  
Levee Inspections  
Unit Cover Sheet  
Spring 2012 Levee Inspection Results  
Reclamation District No. 1600 Mull**

**Levee Inspection Report By Mile - Spring 2012**

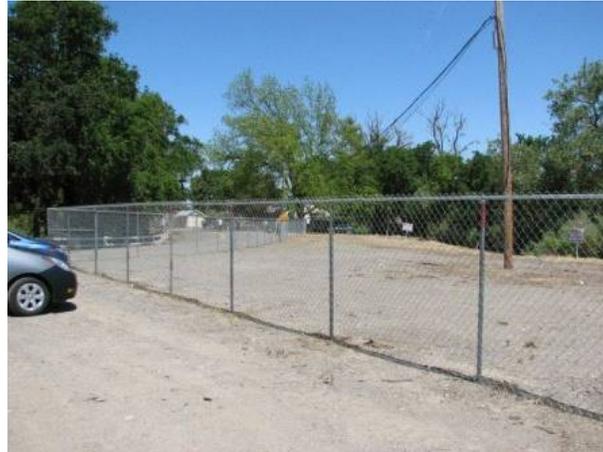
Levee Mile Report Line	4
Start Levee Mile	0.01
End Levee Mile	0.09
Location	Water Side
Category	Earthen Levee
Item	Encroachments
Chain link fence no permit. The building and pumping plant in background is an issue.	
johngw_s_20120313_448.jpg

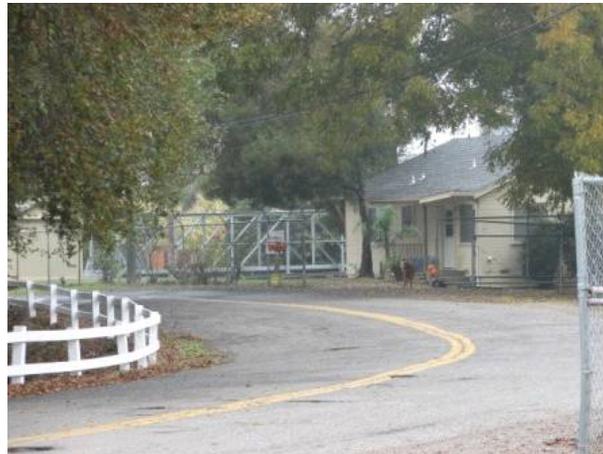
Levee Mile Report Line	5
Start Levee Mile	0.06
End Levee Mile	0.06
Location	Water Side
Category	Earthen Levee
Item	Encroachments
The house of the operator of the pumping plant for RD 2035.	
johngw_s_20120313_447.jpg

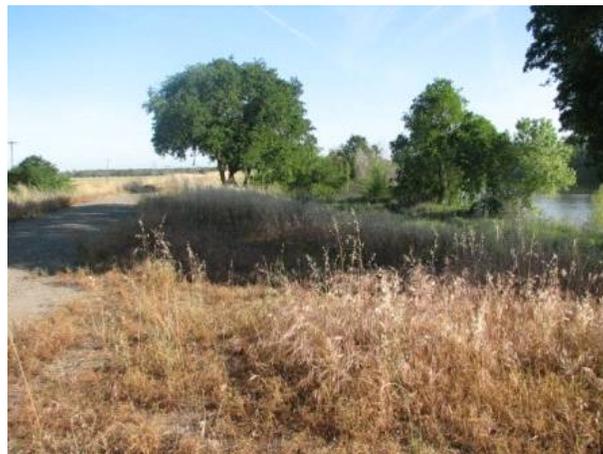
Levee Mile Report Line	6
Start Levee Mile	0.10
End Levee Mile	10.51
Location	Water Side
Category	Earthen Levee
Item	Vegetation
The grasses are taller than 12". Photo taken spring 2012.	
johngw_s_20120509_809.jpg

6	0.10	10.51	Earthen Levee	Vegetation	WS	M Ma	V1 : Control annual grass and weeds on the levee slopes and easements.	38.676480 ° -121.631215 °	38.765508 ° -121.634930 °	215 Y
								DWR ID: DWR_RD1600_01_s_2012_215		
7	0.10	10.51	Earthen Levee	Vegetation	LS	M Ma	V1 : Control annual grass and weeds on the levee slopes and easements.	38.676475 ° -121.631218 °	38.765515 ° -121.634913 °	214 Y
								DWR ID: DWR_RD1600_01_s_2012_214		
8	0.10	0.10	Earthen Levee	Encroachments	WS	M En	DE : Debris Inspector Comments: Pile of concrete	38.676480 ° -121.631220 °	38.676480 ° -121.631220 °	29 Y
								DWR ID: DWR_RD1600_01_s_2012_29		
9	0.10	0.24	Earthen Levee	Vegetation	WSA/W	Ob	V8 : Environmental Requirements.	38.676480 ° -121.631220 °	38.678140 ° ##### °	49 Y
								DWR ID: DWR_RD1600_01_s_2012_49		
10	0.46	0.46	Supplemental	USACE Erosion Survey	WS	M Ma	Inspector Comments: 2000 - Very cohesive vertical bank. 2003 - Some minor new erosion. 2006 - Some minor erosion in old pockets. 2009 - Minimal new erosion. 2011: Multiple new erosion pockets and a few new tree popouts. [2011 Site ID: SAC_71-3_R]	38.682707 ° -121.633830 °	38.684106 ° -121.634219 °	6 Y

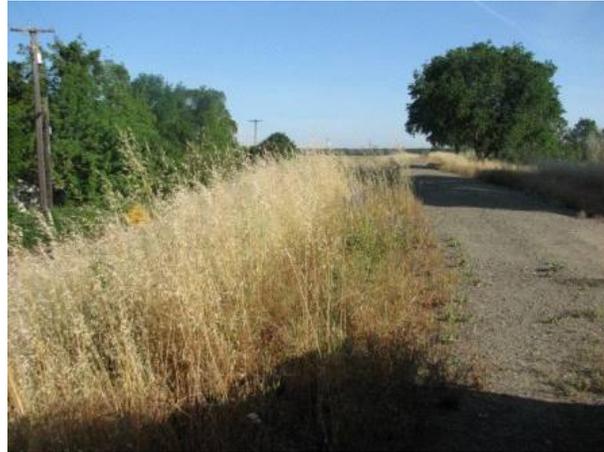
Levee Mile Report Line	7
Start Levee Mile	0.10
End Levee Mile	10.51
Location	Land Side
Category	Earthen Levee
Item	Vegetation
The grasses are taller than 12". Photo taken spring 2012.	
johngw_s_20120509_810.jpg

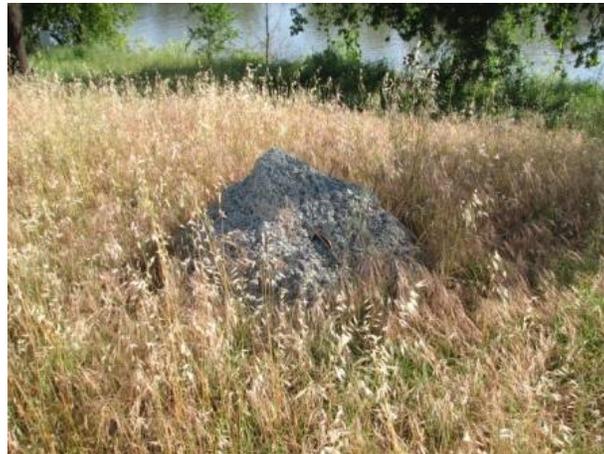
Levee Mile Report Line	8
Start Levee Mile	0.10
End Levee Mile	0.10
Location	Water Side
Category	Earthen Levee
Item	Encroachments
A pile of concrete left over from the drilling of the well. Photo taken spring 2012.	
johngw_s_20120509_811.jpg

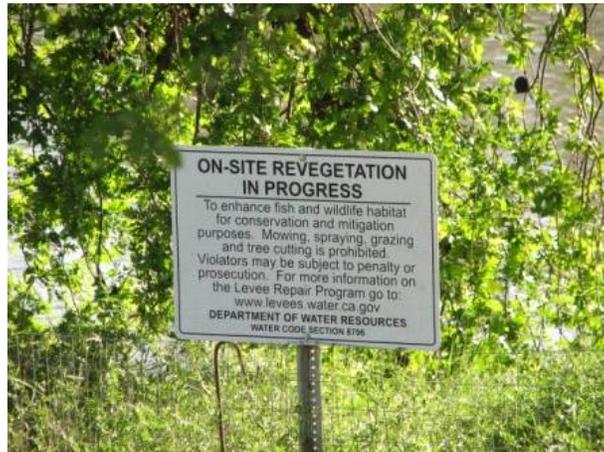
Levee Mile Report Line	9
Start Levee Mile	0.10
End Levee Mile	0.24
Location	Water Side
Category	Earthen Levee
Item	Vegetation
Revegetation site. Photo taken spring 2012.	
johngw_s_20120509_812.jpg

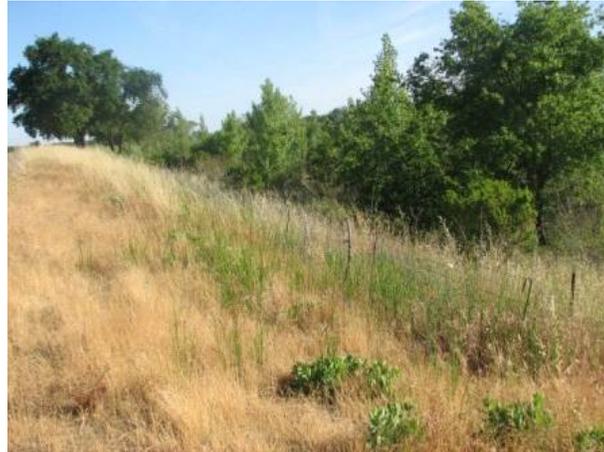
Levee Mile Report Line	9
Start Levee Mile	0.10
End Levee Mile	0.24
Location	Water Side
Category	Earthen Levee
Item	Vegetation
The revegetation site on the berm with the fence showing. Photo taken spring 2012.	
johngw_s_20120509_813.jpg

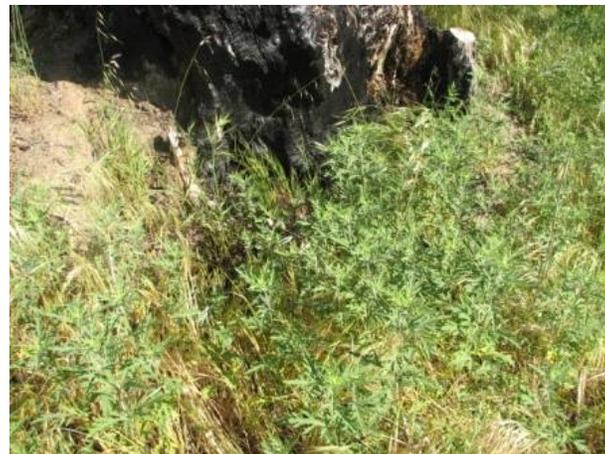
DWR ID: DWR_RD1600_01_s_2012_6		
11	0.98	0.98	Earthen Levee	Animal Control	WS	U Ma	A3 : No rodents visible, but rodent burrows visible; need to backfill and compact or grout burrows.	38.688428 ° -121.635498 °	38.688428 ° -121.635498 °	2 Y
								DWR ID: DWR_RD1600_01_s_2012_2		
12	1.02	1.11	Earthen Levee	Vegetation	WSA/W	Ob	V8 : Environmental Requirements.	38.689078 ° -121.635605 °	38.690267 ° -121.635650 °	22 Y
								DWR ID: DWR_RD1600_01_s_2012_22		
13	1.71	1.71	Earthen Levee	Encroachments	WS	M Ma	MA : Material Inspector Comments: Old metal ramp from unused dock, ramp is on levee shoulder.	38.698364 ° -121.631926 °	38.698364 ° -121.631926 °	9 Y
								DWR ID: DWR_RD1600_01_s_2012_9

Levee Mile Report Line	11
Start Levee Mile	0.98
End Levee Mile	0.98
Location	Water Side
Category	Earthen Levee
Item	Animal Control
A very large hole on the waterside of the oak tree. Photo taken spring 2012.	
johngw_s_20120509_814.jpg

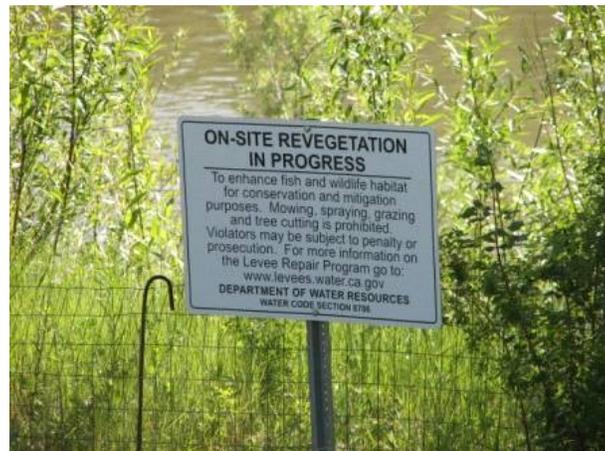
Levee Mile Report Line	12
Start Levee Mile	1.02
End Levee Mile	1.11
Location	Water Side
Category	Earthen Levee
Item	Vegetation
Revegetation site. Photo taken spring 2012.	
johngw_s_20120509_815.jpg

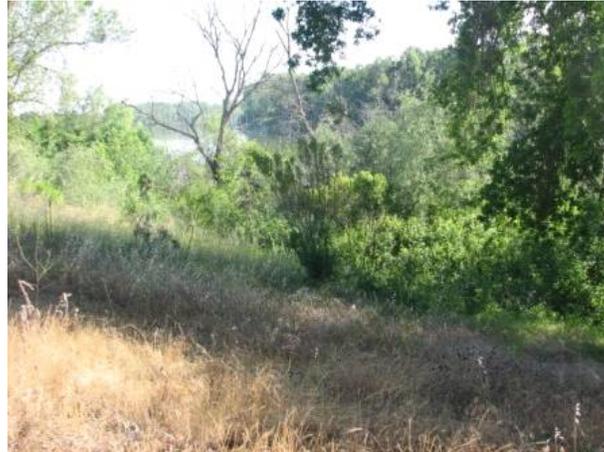
Levee Mile Report Line	12
Start Levee Mile	1.02
End Levee Mile	1.11
Location	Water Side
Category	Earthen Levee
Item	Vegetation
The revegetation site along the berm and shoulder of the river.	
johngw_s_20120509_816.jpg

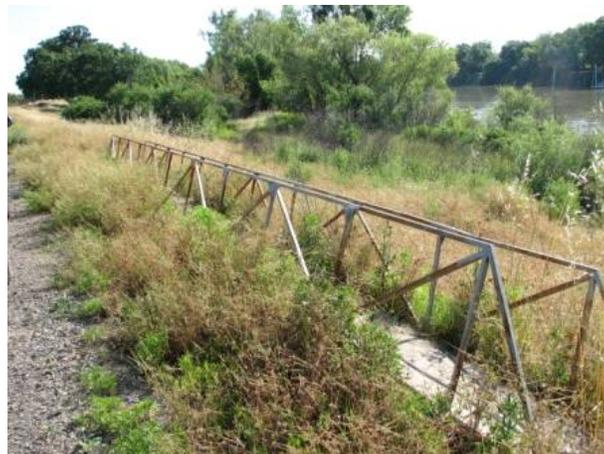
Levee Mile Report Line	13
Start Levee Mile	1.71
End Levee Mile	1.71
Location	Water Side
Category	Earthen Levee
Item	Encroachments
Ramp for dock not being used.	
johngw_s_20120313_455.jpg

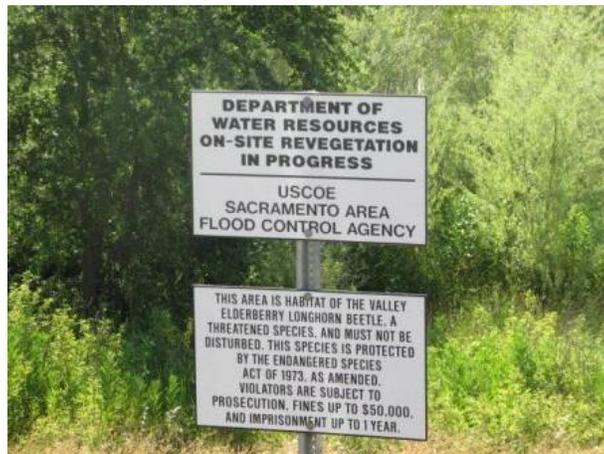
Levee Mile Report Line	14
Start Levee Mile	1.73
End Levee Mile	1.73
Location	Water Side
Category	Earthen Levee
Item	Vegetation
Revegetation site with the Elderberry Beetle. Photo taken spring 2012.	
johngw_s_20120509_817.jpg

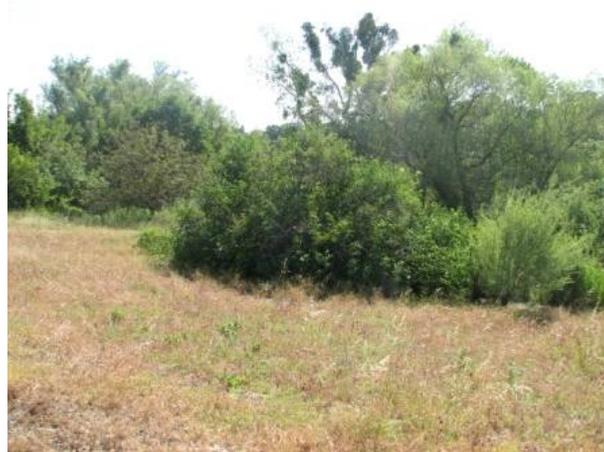
Levee Mile Report Line	14
Start Levee Mile	1.73
End Levee Mile	1.73
Location	Water Side
Category	Earthen Levee
Item	Vegetation

A photo of a Elderberry bush in the area.

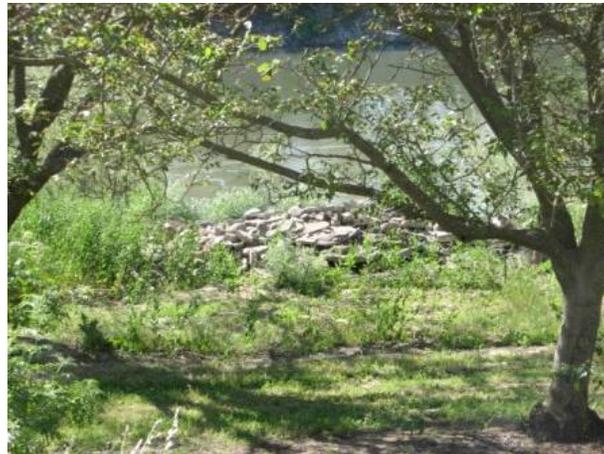
Levee Mile Report Line	15
Start Levee Mile	2.17
End Levee Mile	2.17
Location	Water Side
Category	Earthen Levee
Item	Encroachments

A pile of concrete rubble on the berm. Photo taken spring 2012.

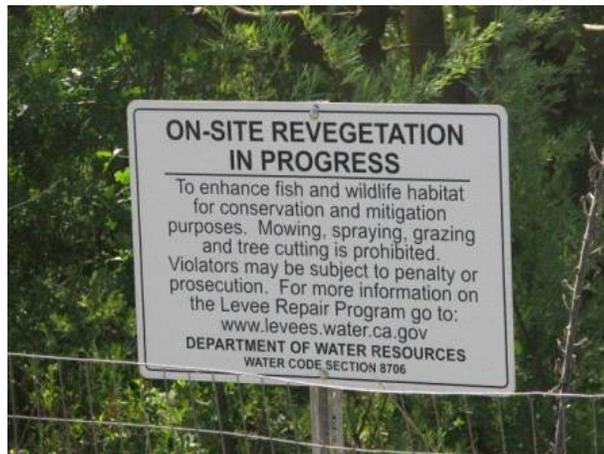
Levee Mile Report Line	16
Start Levee Mile	2.36
End Levee Mile	2.42
Location	Water Side
Category	Earthen Levee
Item	Vegetation

Revegetation site Photo taken spring 2012.

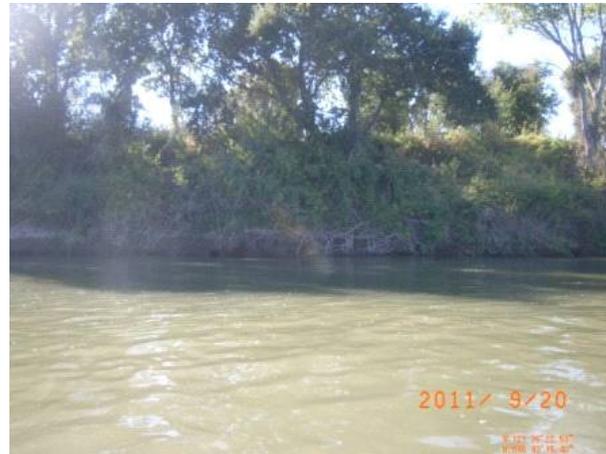
Levee Mile Report Line	18
Start Levee Mile	3.55
End Levee Mile	3.55
Location	Water Side
Category	Supplemental
Item	USACE Erosion Survey
USACE 2011 Photo #1	
johngw_s_20120313_452.jpg

18	3.55	3.55	Supplemental Survey	USACE Erosion Survey	WS	M Ma	Inspector Comments: 1997 - Steep high bank. 2005 - Some small pockets in the low toe near the waterline. 2006 - Minor slope clearing. 2010 - Minor new erosion. 2011: Multiple trees have fallen since last year. Some other trees look ready to fall. Significant new erosion since last year. [2011 Site ID: SAC_74-4_R]	38.717770 ° -121.607423 °	38.721351 ° -121.606414 °	8 Y
DWR ID: DWR_RD1600_01_s_2012_8										
19	4.21	4.21	Supplemental Survey	USACE Erosion Survey	WS	M Ma	Inspector Comments: 1997 - Very steep bank. 2005 - Lots of small trees down along the bank at the upstream end. 2006 - Minor new erosion, but slow. 2010 - Almost all of the roots are exposed on the trees, appears ready to fall. 2011: New erosion and tree popouts. [2011 Site ID: SAC_75-3_R]	38.728684 ° -121.605844 °	38.736110 ° -121.604153 °	10 Y
DWR ID: DWR_RD1600_01_s_2012_10

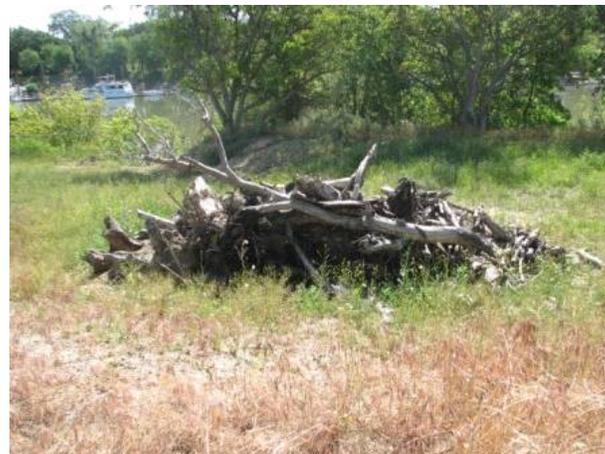
Levee Mile Report Line	24
Start Levee Mile	5.79
End Levee Mile	5.79
Location	Water Side
Category	Earthen Levee
Item	Encroachments
A pruning pile left over from the installation of the new pipe. Photo taken spring 2012.	
johngw_s_20120509_823.jpg

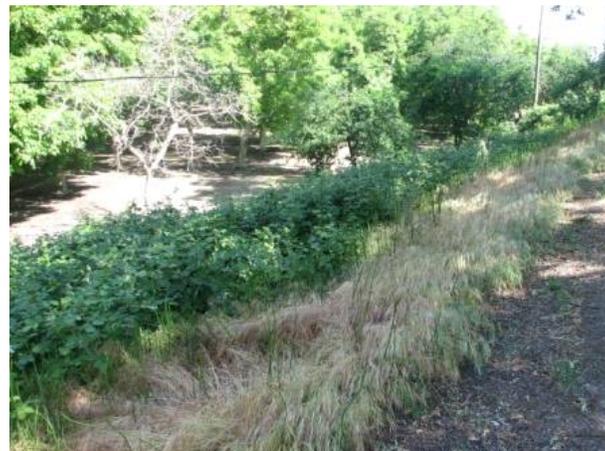
LMIR No.	Levee Mile		Category	Item	Location	Rating	Action/Comment	GPS Latitude/Longitude		Issue No. Photo
	Start	End						Start	End	
26	6.05	6.05	Earthen Levee	Vegetation	LS Ma	M	V2 : Remove the wild growth other than native grasses from the levee slopes. Inspector Comments: Berries cover the slope.	38.751303 ° -121.596087 °	38.751303 ° -121.596087 °	45 Y
								DWR ID: DWR_RD1600_01_s_2012_45		
27	6.23	6.23	Supplemental	USACE Erosion Survey	WS Ma	M	Inspector Comments: 2011: Large vertical eroded face from a rotational failure just below pump. [2011 Site ID: SAC_77-0_R]	38.755246 ° -121.594206 °	38.756186 ° -121.594024 °	11 Y
								DWR ID: DWR_RD1600_01_s_2012_11		
28	6.33	6.33	Earthen Levee	Trim / Thin Trees	LS Ma	C	T1 : Trim trees to at least five feet above ground level. Inspector Comments: Fig tree needs to be trimmed or removed cactus at levee toe.	38.755242 ° -121.594620 °	38.755242 ° -121.594620 °	15 Y

Levee Mile Report Line	26
Start Levee Mile	6.05
End Levee Mile	6.05
Location	Land Side
Category	Earthen Levee
Item	Vegetation
The berries are taking over the slope. Photo taken spring 2012.	
johngw_s_20120509_824.jpg

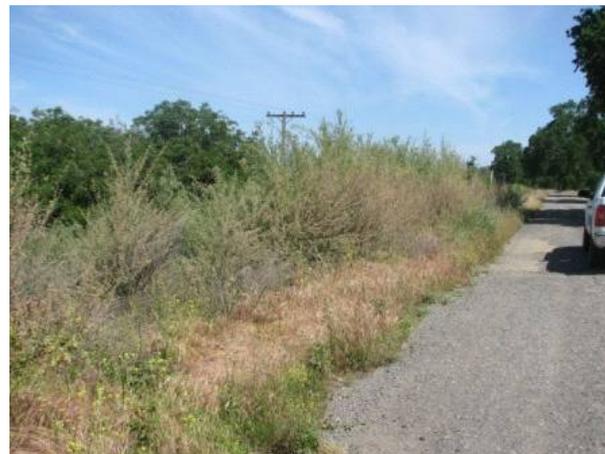
Levee Mile Report Line	29
Start Levee Mile	6.65
End Levee Mile	6.65
Location	Land Side
Category	Earthen Levee
Item	Trim / Thin Trees
The willows need to be cut for visibility of the slope. Photo taken spring 2012.	
johngw_s_20120509_825.jpg

DWR ID: DWR_RD1600_01_s_2012_15		
29	6.65	6.65	Earthen Levee	Trim / Thin Trees	LS Ma	M	T3 : Trim and thin trees to allow visibility of the ground and room to flood fight.	38.759757 ° -121.594112 °	38.759757 ° -121.594112 °	26 Y
								DWR ID: DWR_RD1600_01_s_2012_26		
30	6.97	6.98	Supplemental	USACE Erosion Survey	WS Ma	M	Inspector Comments: 2006 - Eddy scour off end of rock causing erosion and scour hole near levee. Sandy silt bank with rock on upstream end. 2010 - Trees are leaning more, minor new erosion. 2011: Many of the tree roots have scoured out and trees look ready to fall. [2011 Site ID: SAC_77-7_R]	38.765219 ° -121.595049 °	38.764801 ° -121.594926 °	16 Y
								DWR ID: DWR_RD1600_01_s_2012_16		
31	7.00	7.00	Earthen Levee	Erosion / Bank Caving	WSA/W Ma	E1	Note and monitor erosion site.	38.764940 ° -121.595348 °	38.764940 ° -121.595348 °	14 Y
								DWR ID: DWR_RD1600_01_s_2012_14

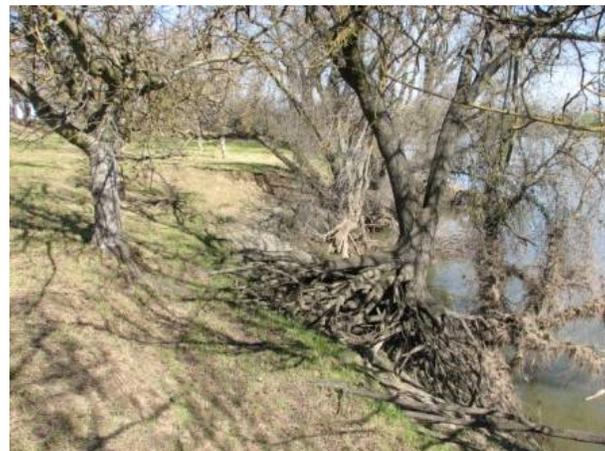
Levee Mile Report Line	31
Start Levee Mile	7.00
End Levee Mile	7.00
Location	Water Side
Category	Earthen Levee
Item	Erosion / Bank Caving
The erosion is continuing to erode the berm area.	
johngw_s_20120313_464.jpg

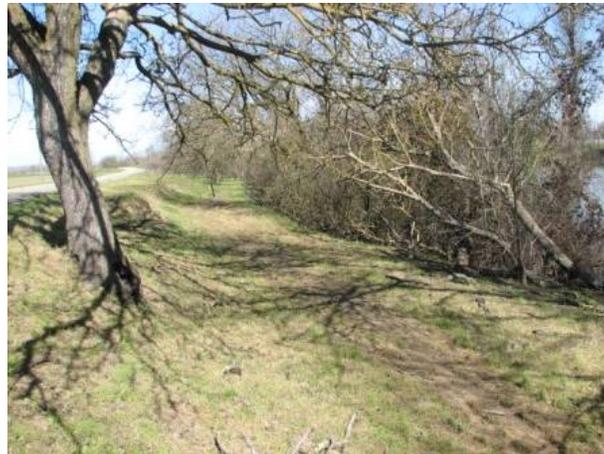
Levee Mile Report Line	33
Start Levee Mile	7.13
End Levee Mile	7.13
Location	Water Side
Category	Earthen Levee
Item	Erosion / Bank Caving
The erosion is eroding away at the berm area.	
johngw_s_20120313_468.jpg

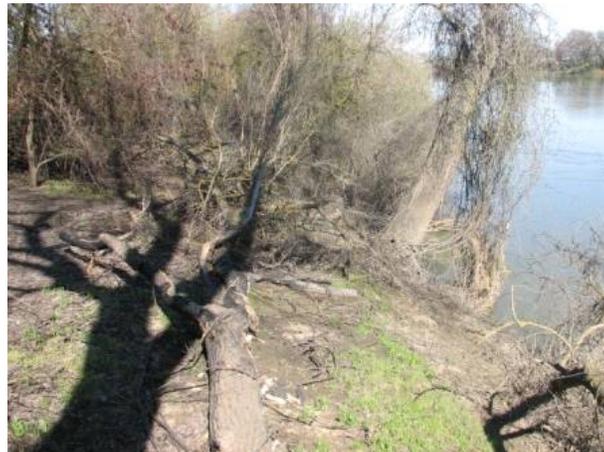
Levee Mile Report Line	33
Start Levee Mile	7.13
End Levee Mile	7.13
Location	Water Side
Category	Earthen Levee
Item	Erosion / Bank Caving
This another view of the site.	
johngw_s_20120313_469.jpg

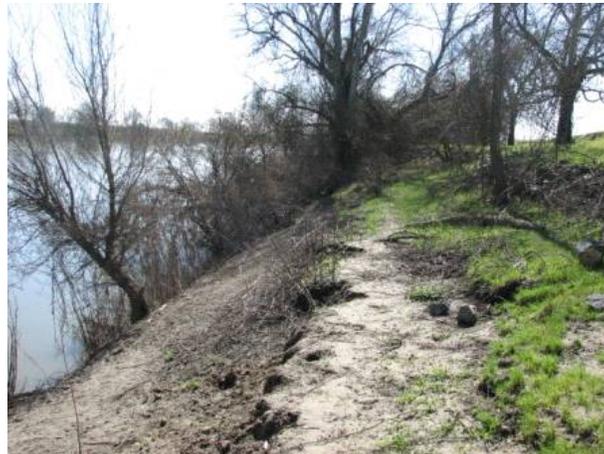
Levee Mile Report Line	34
Start Levee Mile	7.27
End Levee Mile	7.27
Location	Water Side
Category	Earthen Levee
Item	Erosion / Bank Caving
<p>The erosion is eroding away the berm area.</p>	
<p>johngw_s_20120313_471.jpg</p>

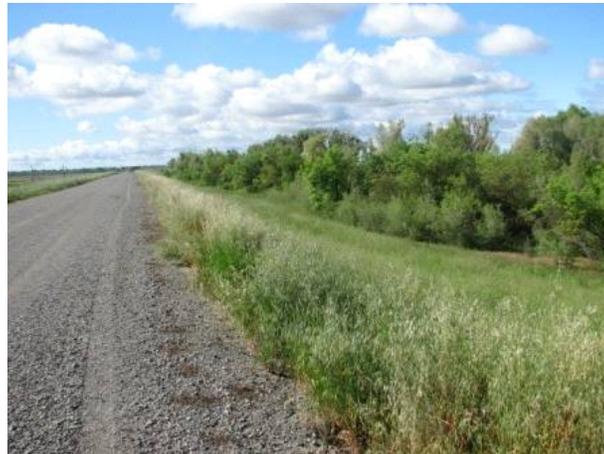
Levee Mile Report Line	2
Start Levee Mile	0.09
End Levee Mile	4.18
Location	Water Side
Category	Earthen Levee
Item	Vegetation
The grasses are taller than 12". Photo taken spring 2012.	
johngw_s_20120430_744.jpg

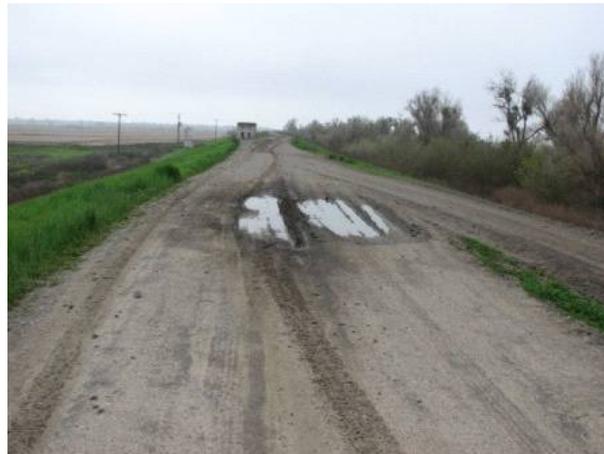
Levee Mile Report Line	3
Start Levee Mile	0.22
End Levee Mile	0.22
Location	Crown
Category	Earthen Levee
Item	Crown Surface / Depressions / Rutting
The crown needs to be graded and AB added to the crown.	
johngw_s_20120313_482.jpg

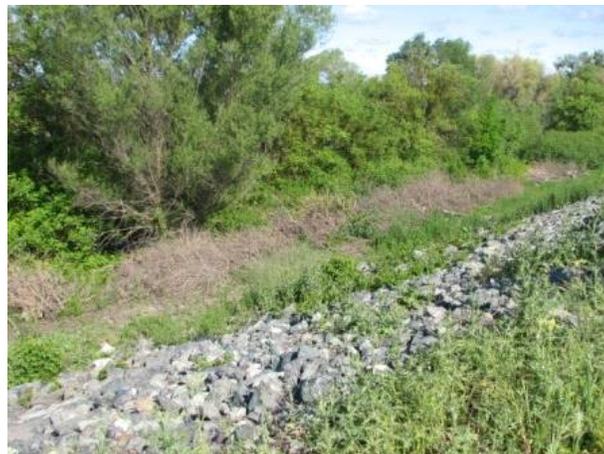
Levee Mile Report Line	5
Start Levee Mile	0.49
End Levee Mile	0.49
Location	Water Side
Category	Earthen Levee
Item	Encroachments
Pruning piles along the the waterside toe of the levee. Photo taken spring 2012.	
johngw_s_20120430_746.jpg

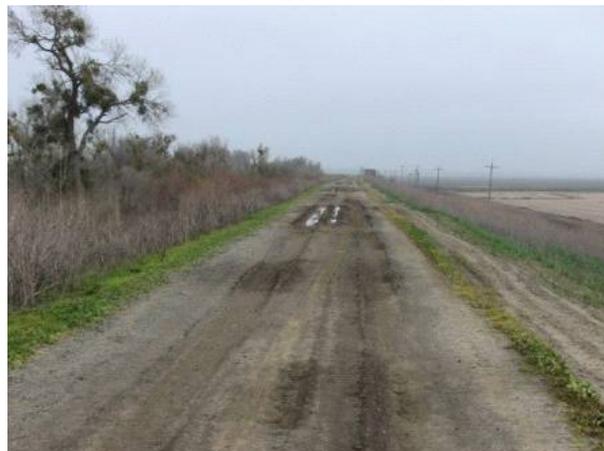
Levee Mile Report Line	6
Start Levee Mile	0.68
End Levee Mile	0.77
Location	Crown
Category	Earthen Levee
Item	Crown Surface / Depressions / Rutting
This area is soft and needs to have AB added to make an all weather surface.	
johngw_s_20120313_483.jpg

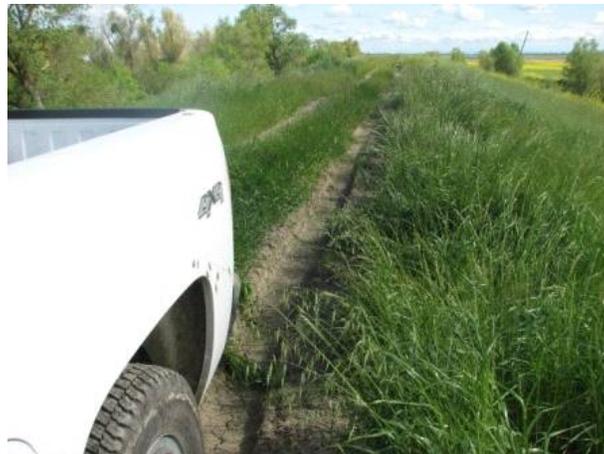
Levee Mile Report Line	8
Start Levee Mile	1.65
End Levee Mile	1.65
Location	Crown
Category	Earthen Levee
Item	Crown Surface / Depressions / Rutting
Tire ruts are deeper than 6", the crown needs to be graded. Photo taken spring 2012.	
johngw_s_20120430_748.jpg

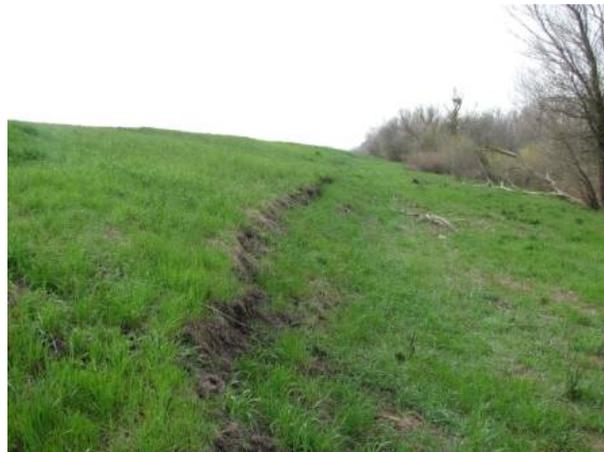
Levee Mile Report Line	9
Start Levee Mile	1.74
End Levee Mile	2.01
Location	Water Side
Category	Earthen Levee
Item	Erosion / Bank Caving
Wave wash damage along the slope the cut is 1'-2'.	
johngw_s_20120313_484.jpg

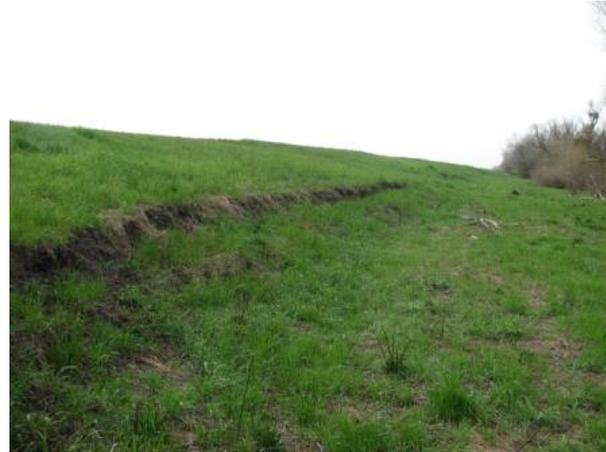
Levee Mile Report Line	9
Start Levee Mile	1.74
End Levee Mile	2.01
Location	Water Side
Category	Earthen Levee
Item	Erosion / Bank Caving
A closer view of the wave wash damage along the bypass.	
johngw_s_20120313_485.jpg

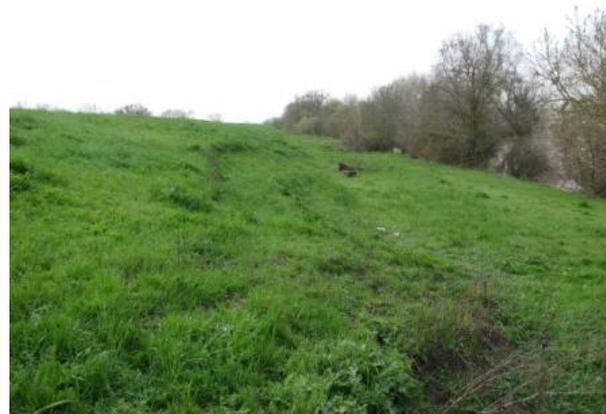
DWR ID: DWR_RD1600_02_s_2012_14										
10	2.12	2.23	Earthen Levee	Erosion / Bank Caving	WS	M Ma	E1 : Note and monitor erosion site. Inspector Comments: This is wave wash damage caused by last high water.	38.705614 ° -121.639357 °	38.704052 ° -121.640016 °	15 Y
DWR ID: DWR_RD1600_02_s_2012_15										
11	2.19	3.83	Earthen Levee	Crown Surface / Depressions / Rutting	CR	M Ma	C3 : Add appropriate gravel or road base. Grade and compact. Inspector Comments: The areas on the crown. I have marked are the worst areas. The entire unit needs to have base added. This is to have all weather road for patrolling.	38.705027 ° -121.639568 °	38.682007 ° -121.644305 °	3 Y
DWR ID: DWR_RD1600_02_s_2012_3

Levee Mile Report Line	10
Start Levee Mile	2.12
End Levee Mile	2.23
Location	Water Side
Category	Earthen Levee
Item	Erosion / Bank Caving
This is wave wash damage along the toe of the levee looking downstream.	
johngw_s_20120313_486.jpg

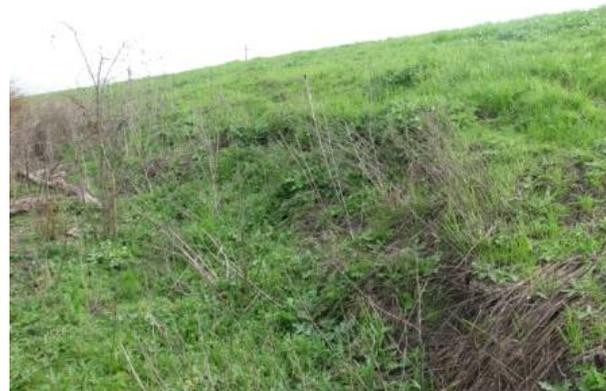
Levee Mile Report Line	10
Start Levee Mile	2.12
End Levee Mile	2.23
Location	Water Side
Category	Earthen Levee
Item	Erosion / Bank Caving
Looking upstream a deeper cut of 2'-3' damage.	
johngw_s_20120313_487.jpg
